CASE STUDY

The Potential Health Hazard of PP-R Pipe Degradation in Potable Water Delivery System

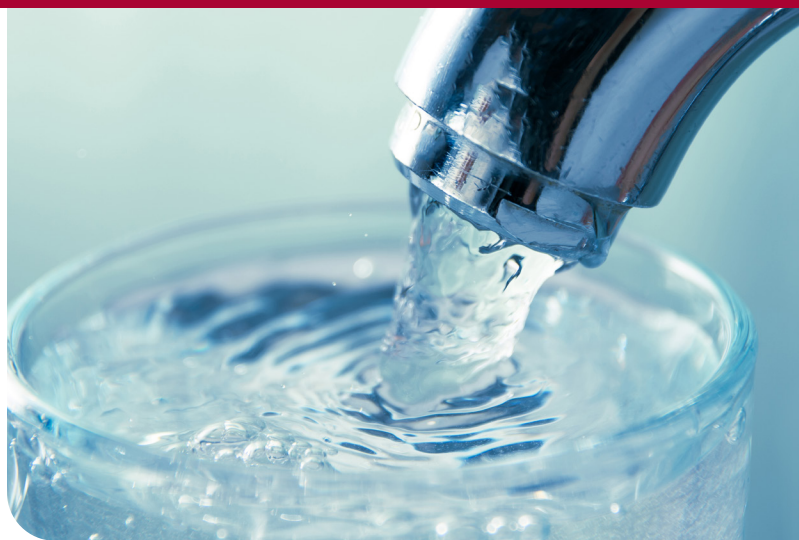
For a multi-family residential complex in southern California, engineers and site managers chose Corzan® Material and Piping Solutions for a re-piping job of the site's existing PP-R piping material. The PP-R potable water delivery system had become heavily degraded in several sections during its 10-year in-service life.

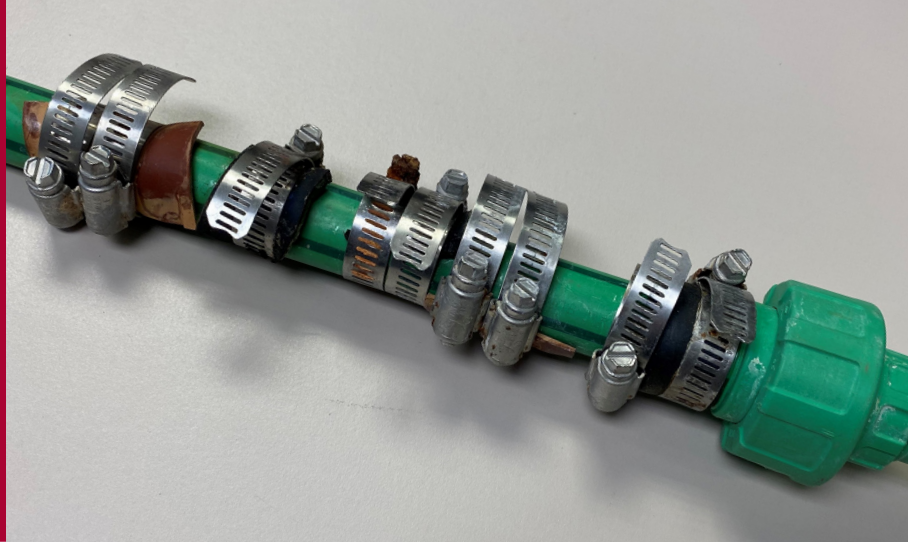
The pipe samples all showed tell-tale signs of degradation, with rough edges, cracking, and green sludge visible to the naked eye.

This section of 2-inch pipe recovered from the site is visibly degraded. When new, PP-R pipes are smooth inside and out. However, this pipe's interior had become ridged, with deep cracks nearly extending to its exterior.

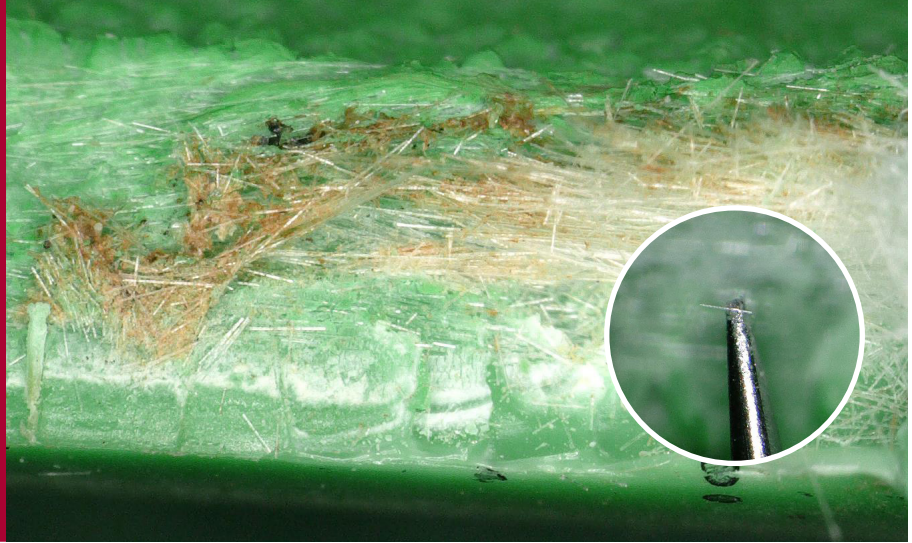
Microscopic magnification revealed an abundance of loose glass fibers protruding from the sample interiors. The fibers were loose enough that scientists could easily shuffle them around and pull them out by poking and prodding in the cracks with a dental probe.

To further investigate, our scientists placed the samples under a microscope. Focusing attention on several large cracks, magnification revealed an abundance of loose glass fibers protruding from the sample interiors.

The fibers, typically added to PP-R and PP-RCT composites as a cost-effective means of reinforcing a pipe's dimensional stability, were loose enough that scientists could easily shuffle them around and pull them out by poking and prodding in the cracks with a dental probe.
